Manhole Inspection Summary

Manhole # S170__023MH

Insp Date: **12/15/08 11:53 AM**

Location Address: **2601 ST BENEDICT-DULANY-ALLEY** Cross Street: **MILLINGTON AV**

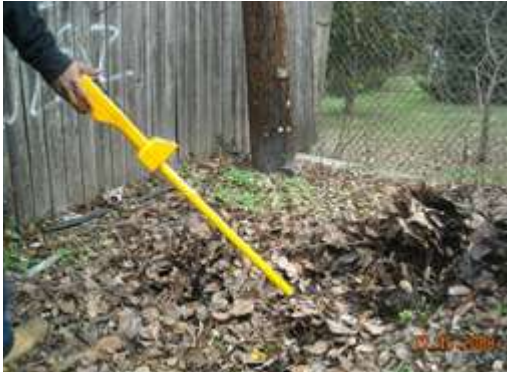
MISC.

LOCATED WITH METAL DETECTOR

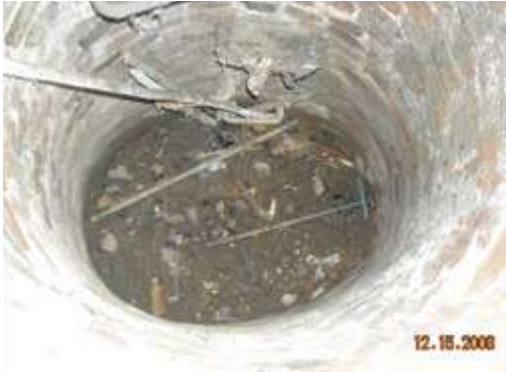
Defect 1

Condition: ☐ Sound ☐ Cracked ☐ Root Intrusion ☐ Deteriorated ☐ Leaks ☒ **Debris**

Surcharge ☒ **Evidence Of Surcharge** Depth: **3** (ft.) ☐ Active Surcharge Present

channel debris, surcharge evidence

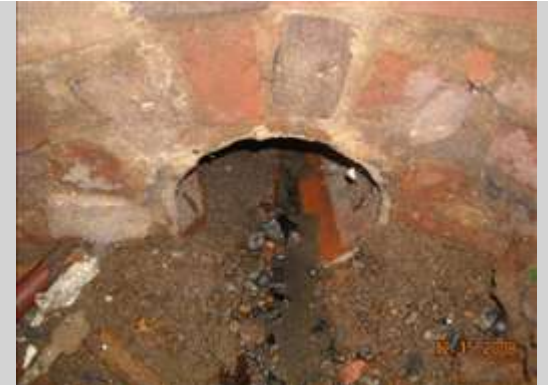
12 O'Clock Outflow

8 in. Circular Gravity Sewer
Pipe Out @ 12 O'Clock

Deposits: ☐ None ☒ **Mud** ☐ Sludge ☐ Debris ☐ Grease

Silt Depth: **1** (in.) Deposits Extent: **Light**
